# National Transportation Safety Board Aviation Accident Preliminary Report

<b>Location:</b>	Truckee, CA	<b>Accident Number:</b>	WPR21FA286
<b>Date &amp; Time:</b>	July 26, 2021, 13:18 Local	<b>Registration:</b>	N605TR
<b>Aircraft:</b>	BOMBARDIER INC CL-600-2B16	<b>Injuries:</b>	6 Fatal
<b>Flight Conducted Under:</b>	Part 91: General aviation - Personal

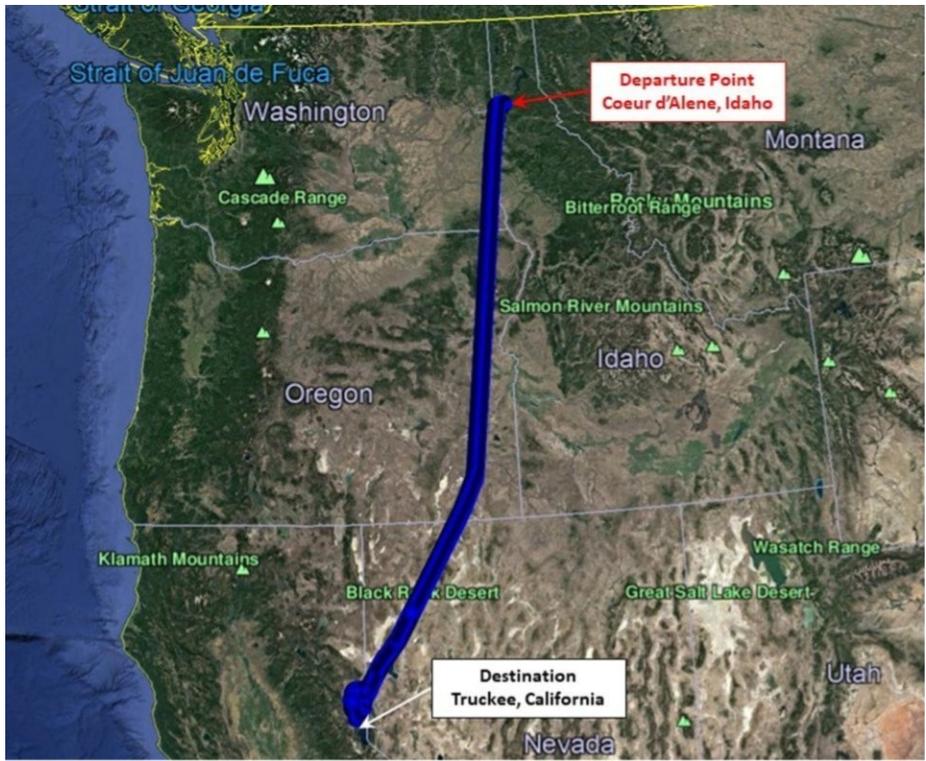
Figure 1: N605TR flight path

According to automatic dependent surveillance-broadcast (ADS-B) data and preliminary air traffic control (ATC) audio from the Federal Aviation Administration, the airplane departed Coeur d'Alene, Idaho, about 1145 (see Figure 1) and made a left turn to the south. The flight crew was in contact with ATC throughout the duration of the flight. As the airplane was passing over northwestern Nevada, ATC began issuing descent instructions for the airplane's approach into Truckee-Tahoe Airport (TRK). Once the airplane descended below 26,000 ft, ATC advised the flight crew to expect the RNAV (GPS) Runway 20 approach at TRK. The flight crew accepted the approach but requested to circle to runway 11 for the longer runway and the controller told them to expect the circling approach. After coordinating with the TRK tower, the controller informed the flight crew that they would be number two for TRK and could expect some delays. ATC then cleared the airplane to hold north of the ALVAA waypoint, the initial approach fix to the RNAV runway 20 approach. After one turn in holding (see Figure 2), ATC cleared the airplane for the RNAV runway 20 approach, cancelled radar services, and instructed the pilot to contact the TRK tower. The flight crew established communication with the TRK tower controller when they were near the LUMMO waypoint, located about 9.6 nm north of the approach end of runway 20. The tower controller offered the flight crew the option of crossing over the field and enter the left downwind leg for runway 29 or to enter downwind leg for runway 11. Once the flight crew announced they were making a right turn (see Figure 3) and reported runway 11 in sight, the controller then cleared them to land on runway 11 and informed them that the airplane was not in sight. The flight crew acknowledged the clearance, which was their final radio communication.

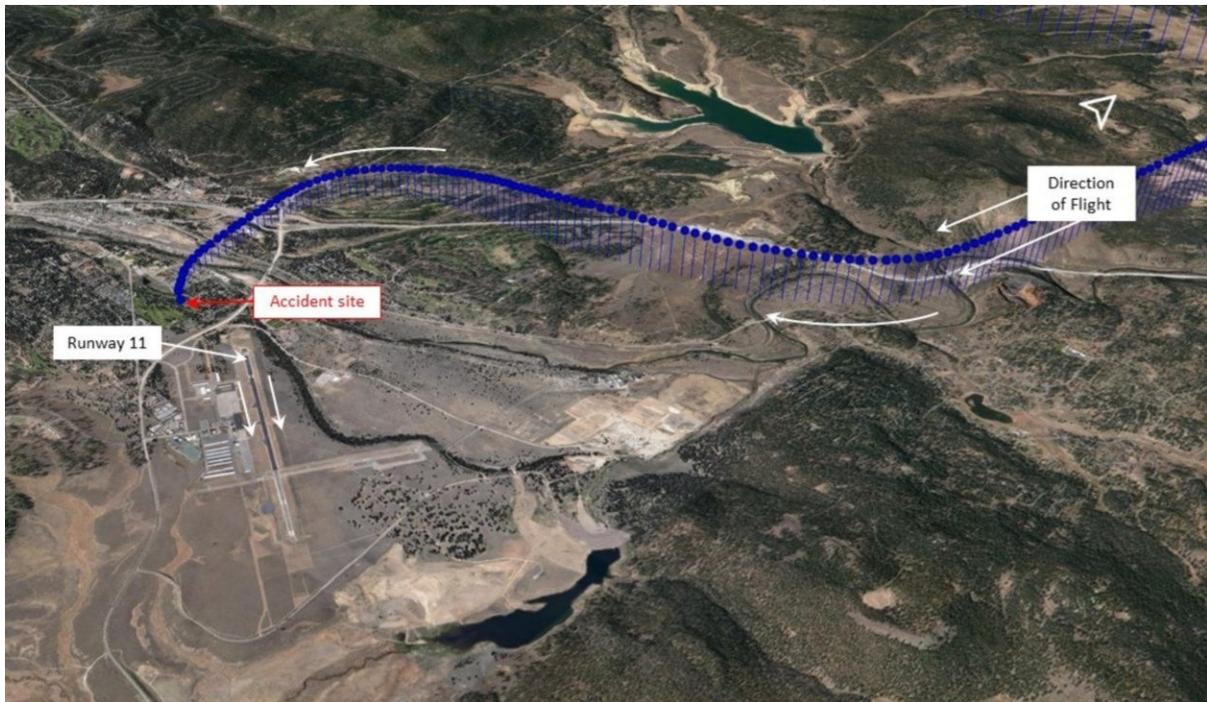
*Figure 3: Truckee-Tahoe airport and N605TR flight path*

Multiple eyewitnesses observed the airplane before the crash. Some reported that the airplane caught their attention because of its low altitude and abnormal flight path into runway 11. According to witnesses, the airplane was in a nose down attitude and steep left turn during its last few seconds of flight. A witness located about 50 ft from the accident site reported that he observed the airplane come from the northwest about 20 ft above the trees. The airplane then entered a steep left turn and banked erratically just before it impacted trees and then the ground. The witnesses close to the accident site stated that the airplane appeared intact when they first observed it.

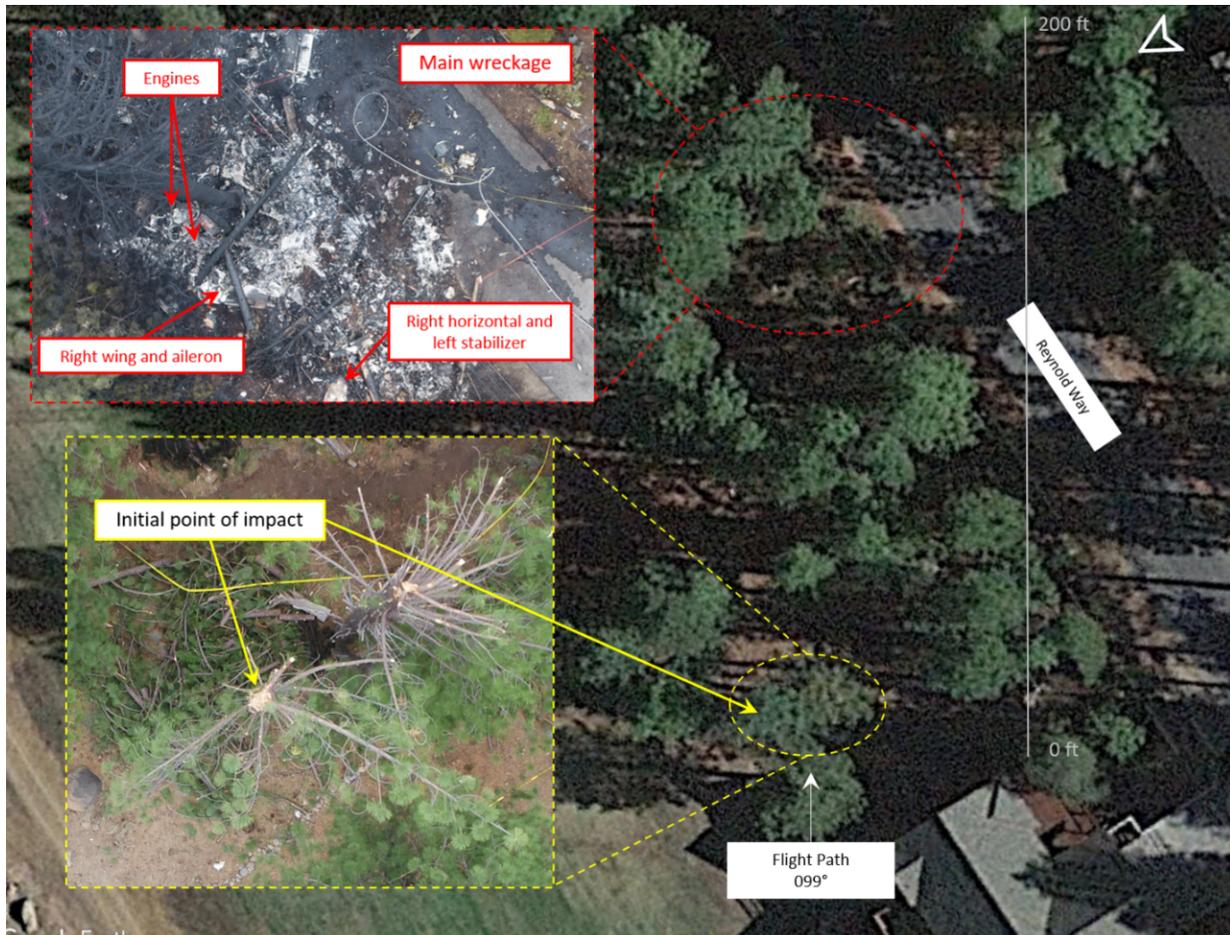
Figure 4: Wreckage path and diagram

The accident site was located on a hillside between a golf course fairway and a residential street. The airplane was consumed by postcrash fire. A debris path, which measured about 225 ft long and 85 ft wide was marked by several broken trees and was oriented on an easterly heading. (see Figure 4). The initial point of impact was identified by a severed tree that stood about 70 ft tall, located about 120 ft west of the main wreckage. Portions of the right and left wings and control surfaces were found fragmented along the debris path. Additional airframe fragments were collocated with the main wreckage, which was comprised of both engines, the empennage, and fuselage remnants.
